Release Notes

WITE32

Version 3.21

03/17/2005

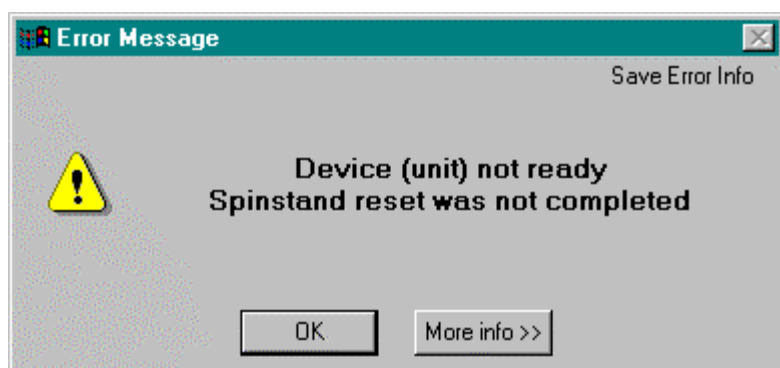
Figure 2 Incomplete Reset Warning Message

In the case you pressed the *Cancel* button, you will get the warning message shown on the Figure 2 below.

WITE32 will start, however, you will not be able to start the device or perform any spinstand operations until you press the Red button on the spinstand front panel to repeat the *Reset* procedure.

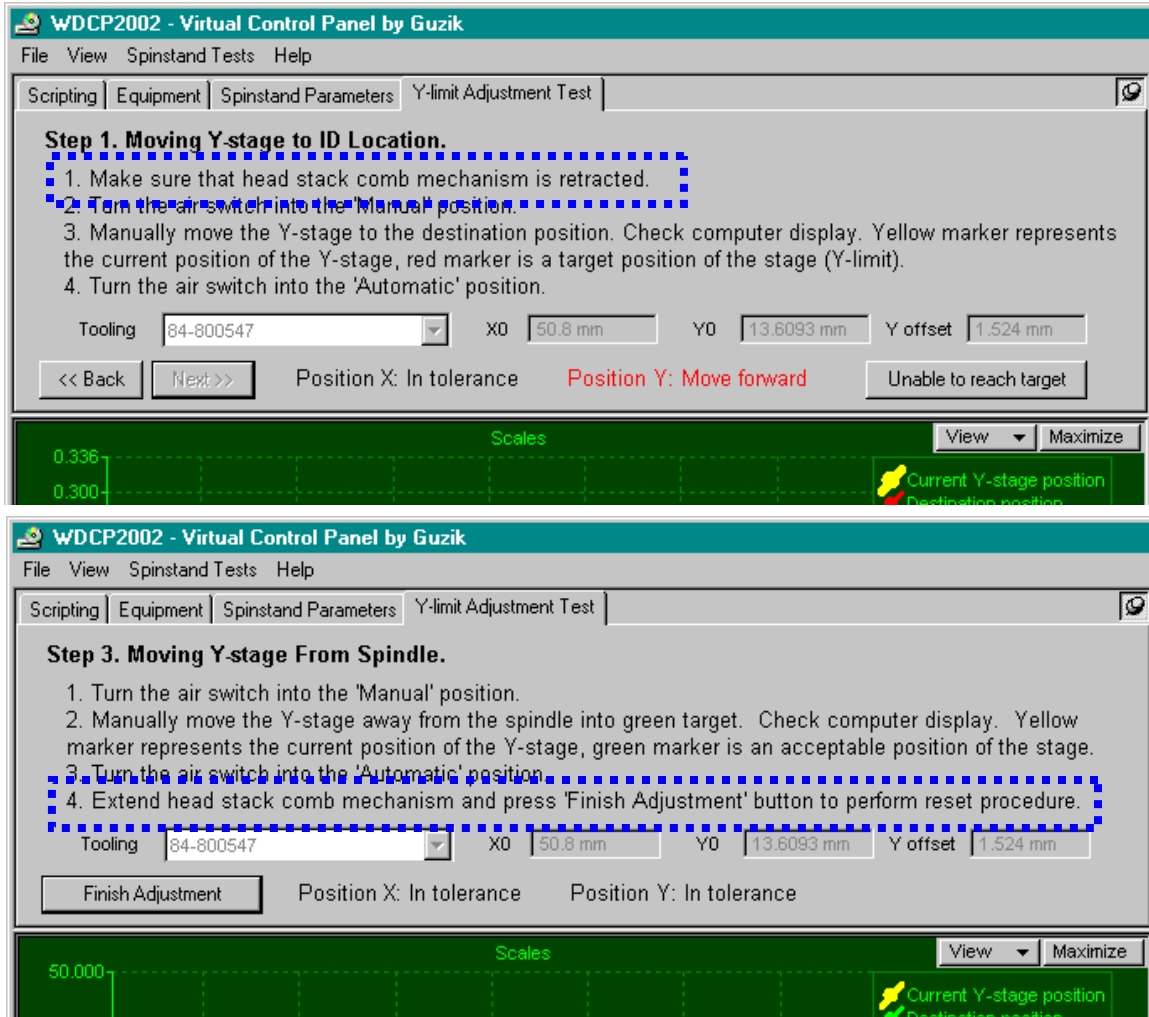
Figure 3 Additional Head Stack Y-Limit Adjustment Instructions

The *Y-Screw Limit Adjustment* test for V2002 Head Stack tooling is modified starting from the WITE32 version 3.21. If the Head Stack touches the crash protection sensor during the *Y-Screw Limit Adjustment* test, or comb mechanism is retracted, the spindstand cannot perform a reset, and it cannot successfully finish the *Y-Screw Limit Adjustment* test. To prevent these conditions the additional instructions for the Head Stack tooling are added to Step 1 and 3 of *Y-Screw Limit Adjustment* test, see Figure 3 below.
