## Release Notes

# **WITE32**

**Version 4.04**

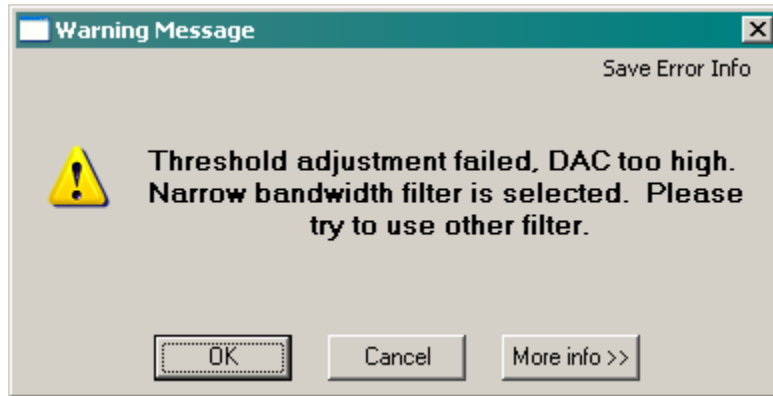
If PW measurements are configured to use the *Overwrite* filter (Spectrum Analyzer), the error message now recommends to use another filter, see Figure 1.

Figure 1: Warning message if PW is measured through the Overwrite filter

In previous version of WITE32 the error message "*Threshold adjustment failed, DAC too high*" was correct but confusing. The threshold adjustment fails because there are no pulses or rise/fall slopes on the output of the Overwrite (narrow bandwidth) filter.

In general we do not recommend specifying the Overwrite filter as a system filter, but select it explicitly in the setups of the tests, which are chosen to perform the measurement through the Overwrite filter, such as *W/R Offset*, *Track Profile* etc.
